AEFA Project No. 88-06

# ARTIFICIAL AND NATURAL ICING TESTS OF THE EH-60A QUICK FIX HELICOPTER

June 1988

Final Report

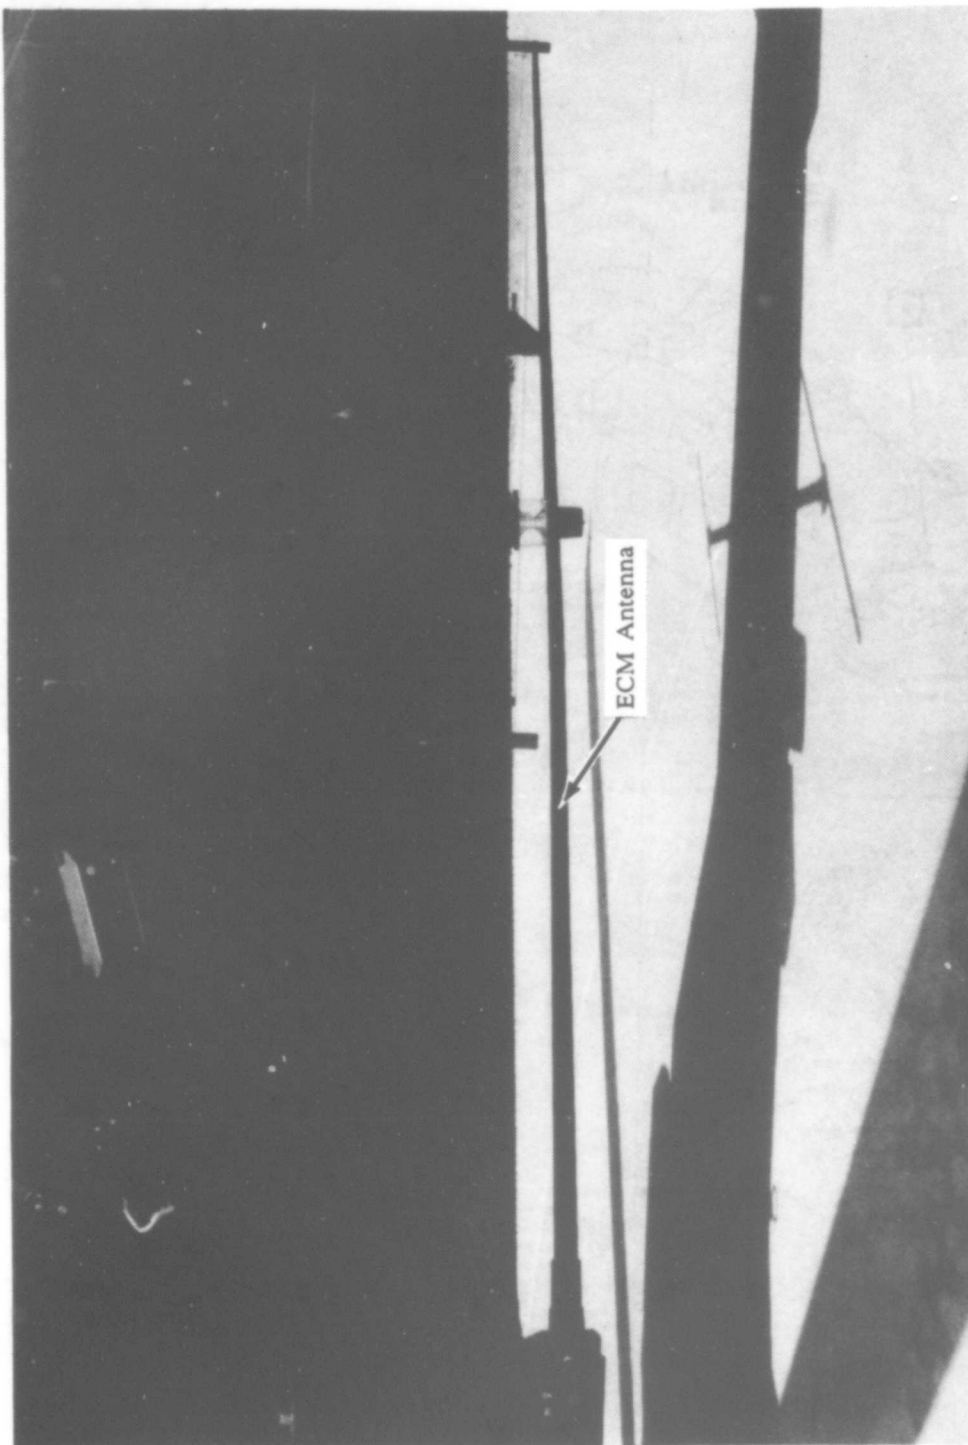
Figure B-7. ECM Antenna (Retracted)

23. Following a natural icing flight of 1.5 hours duration at  $-9.3^{\circ}\text{C}$  with a LWC of  $0.2 \text{ gm/m}^3$ , the ECM antenna failed to fully retract to the stowed position (fig. H-20). The aircraft was brought to a hover and the ECM antenna removed from the antenna mount. Post flight inspection revealed the right pivot stud on the antenna mount had sheared (fig. H-21). The sheared pivot stud permitted the antenna mount to skew in the housing during retraction resulting in the antenna mount being jammed against the housing. The left pivot stud was bent and the actuator connecting point to the stud arm subassembly would not rotate due to torsion damage (fig. H-22). The ECM antenna was removed for the remainder of the tests. The TIR submitted by AEFA is presented in

appendix G. The damage to the pivot stud of the ECM antenna mount following an icing encounter, preventing full retraction of the ECM antenna, is a shortcoming.
